EVC OI.AC Alarm & Compressor Surging

This **Mandatory** service bulletin applies to all packaged Dx cooling or air-source heat pump units with inverter scroll compressors driven by EVC drives when the EVC drive has a firmware version of 1.54 or 1.57. These units are seeing periodic unexpected Oi.Ac alarms and occasional surging/revving conditions of the compressor at startup.

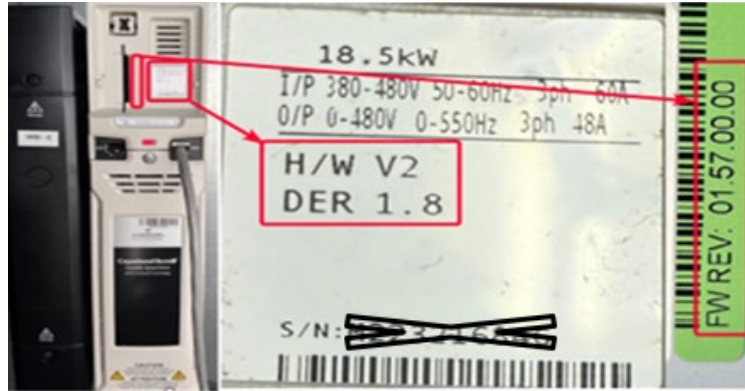
- iv. If Software version is 01.57 or 01.54 a update is required
- b. If a display it not available check the firmware version using the label on the drive
 - i. If H/W V2 and DER 1.8 is printed on the rating label or FW REV: 01.57.00.00 is next to the rating label, the drive must be updated.

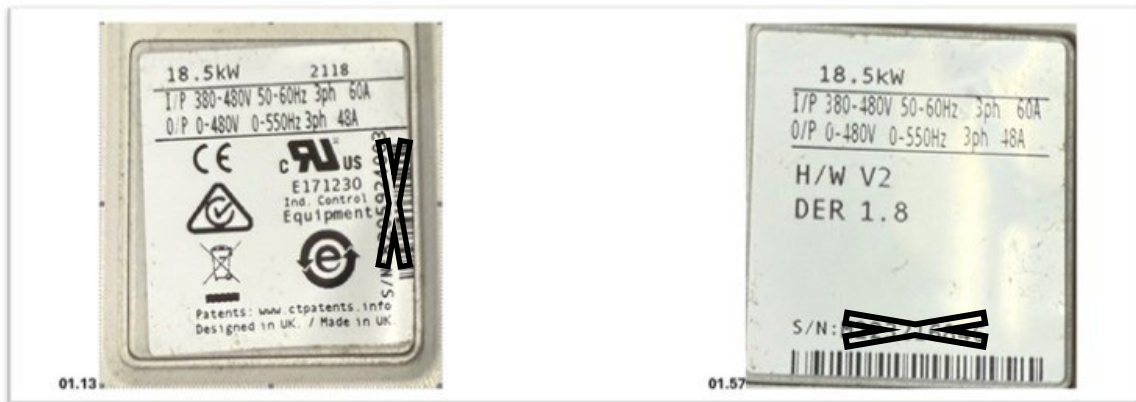
H/W V2 is **NOT** present or the derivate is DER 1.9 or DER 1.10, the firmware on that drive does **NOT** need to be updated.

Example: Left label = no update needed (example pre March 2022, 1.13) Right = requires update (example post March 2022 1.54 or 1.57)

Ignore S/N shown on the labels above. Required S/N on top of drive using separate label.

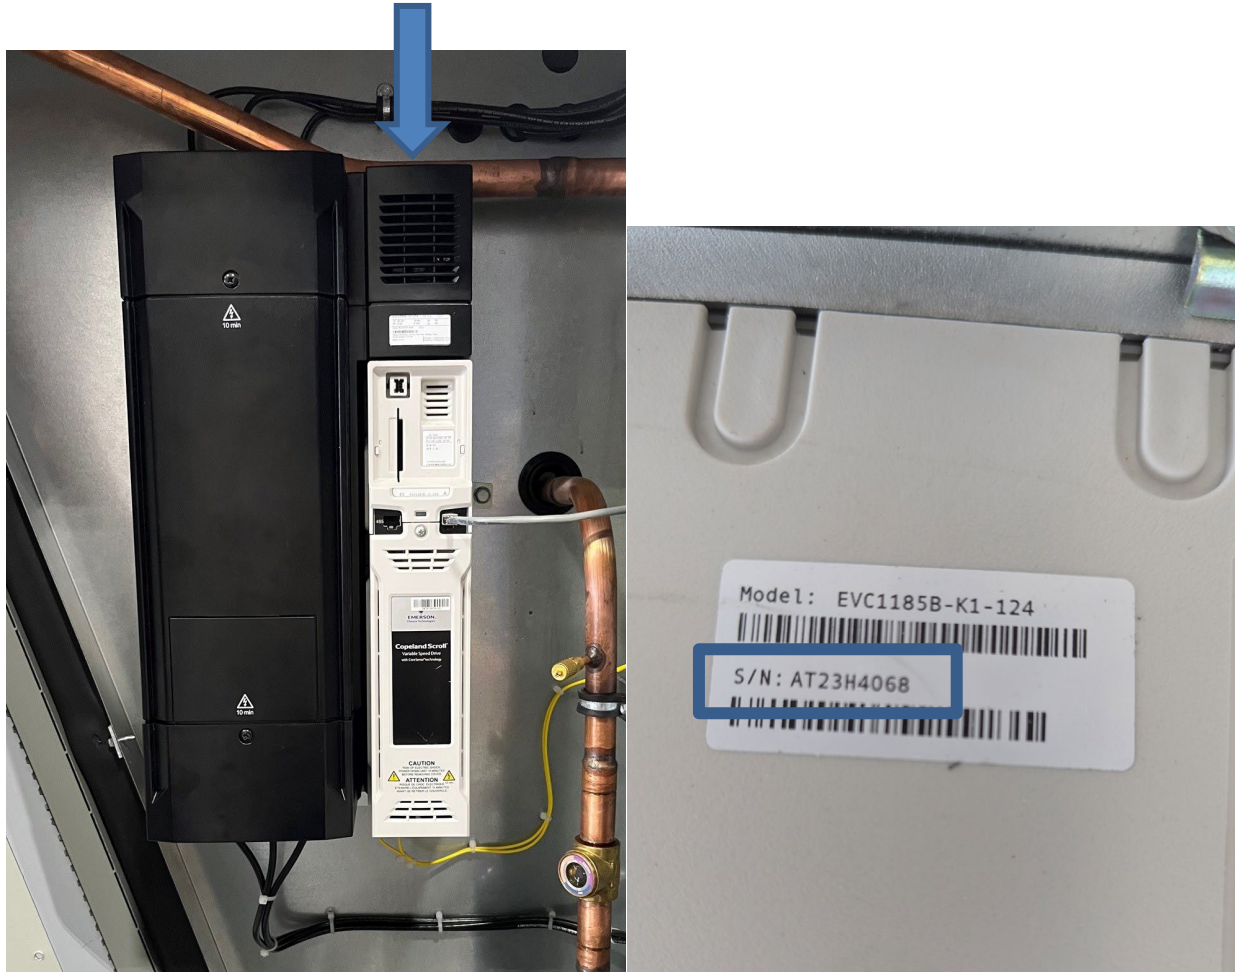
- Find and **Record below** the EVC Drive Serial Number **located on the top of the drive** starting in AT or AY followed by 22, 23, or 24 – NOTE the “S/N” listed on the *front* label is not required.
